TECHNICAL REPORT REMR-CO-3

CASE HISTORIES OF CORPS BREAKWATER
AND JETTY STRUCTURES

Report 7

NEW ENGLAND DIVISION

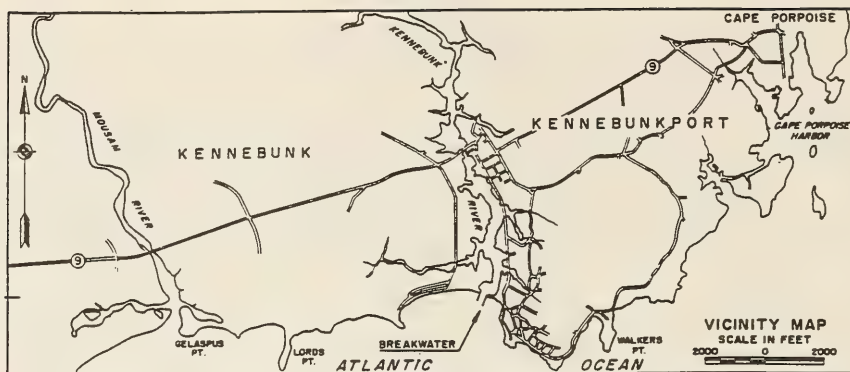
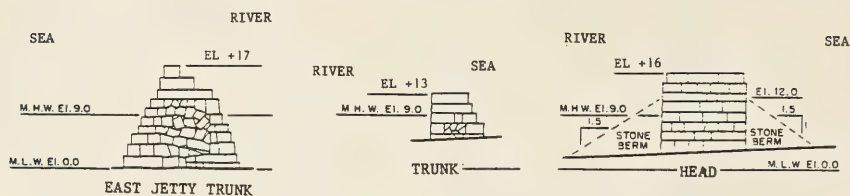
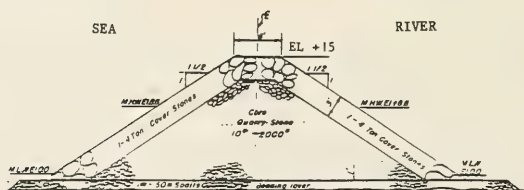
1969	Repairs were made by placing quarried stone on the east jetty seaward slope from approximately 1+00 to 5+00. Also included were repairs of an undermined channel side section between 2+50 and 2+60 and a breached section, with a maximum depression of about 9 ft, between 3+20 and 3+50. Prior inspections between 1964 and 1967 indicated the jetty was in poor condition. The seaward slope armor stone was placed to +16 ft mlw, a minimum, composite top width of 6 ft (including the existing capstone), and a 1V:1.5H side slope. The core consisted of chips to 2,000-lb stone, and the cover layer was 5- to 8-ton stone. The damaged sections were repaired by resetting existing stone blocks and adding new stone. The design channel side slope was 1V:1H. A total of 5,600 tons of stone was placed for a cost of \$100,800. The west jetty was in good condition with only minor displacement of armor stone along the recent extension.

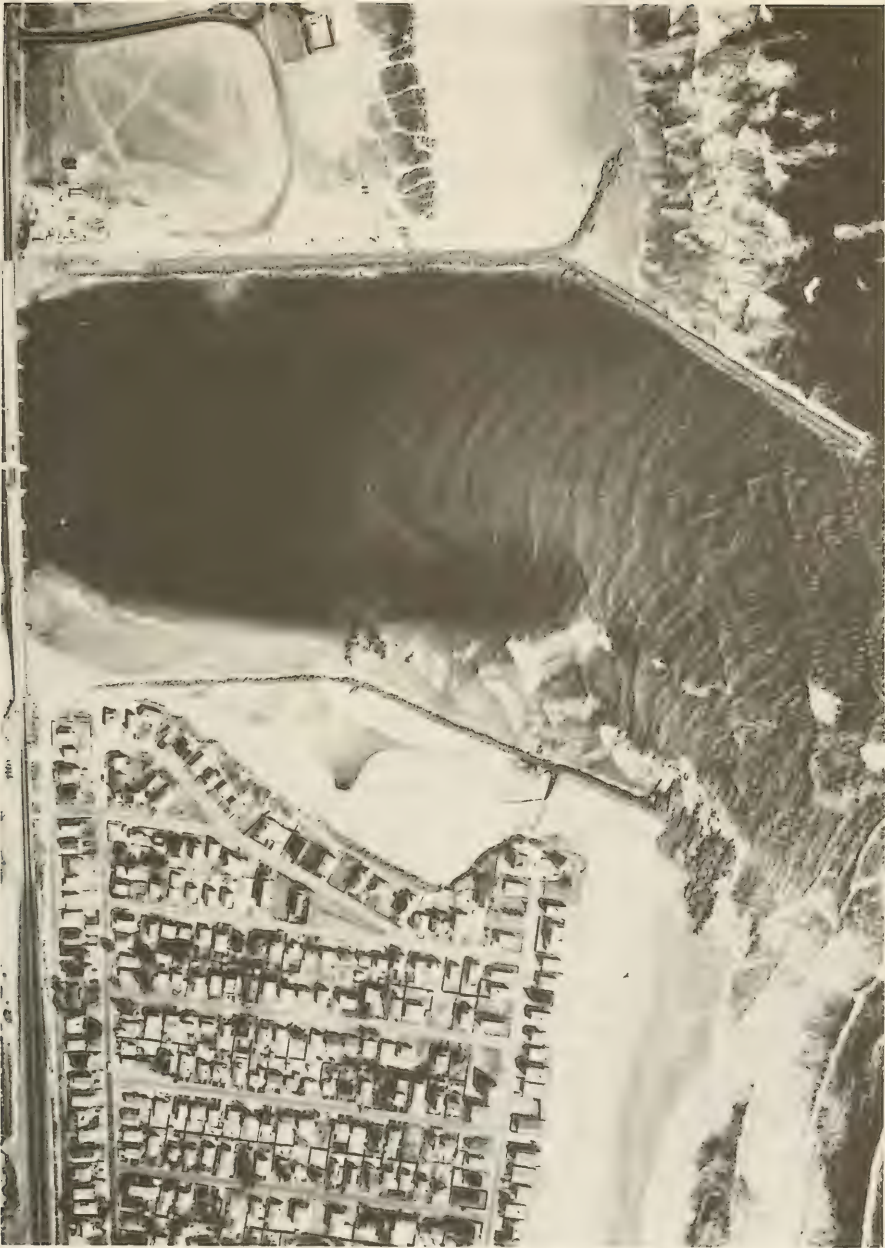
Figure 19. October 1984 photograph of jetties at Hampton Harbor, N.H.

1984	The jetties were inspected and found to be in excellent condition. Figure 19 is an aerial photograph of the jetties taken on 16 October 1984.

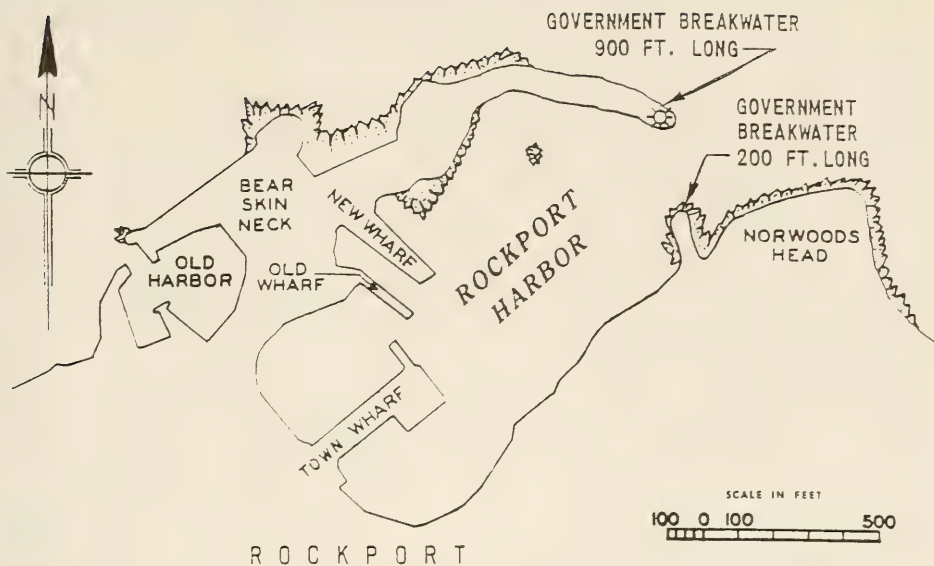
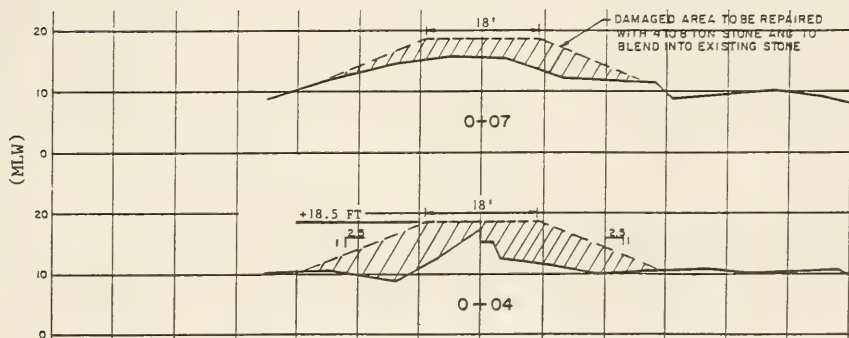
TYPICAL REPAIR SECTION (1977-78)

1970	Repairs were made at the seaward end of Bearskin Neck breakwater where stone had been displaced from a lower portion of the head side slope. The existing head section cover layer had a fairly smooth appearance due to careful placement and addition of concrete grout. Also, iron tie rods had been placed, connecting individual cover stone throughout this section. The remainder of the breakwater is composed of 500-lb to 5-ton stone with an outward appearance typical of rubble-mound structures. The 45-ft-long repair section was located mostly on the harbor side quadrant of the head. Stone weighing 5 to 8 tons was placed at a 1V:2H side slope. The repairs were made for a lump sum of \$25,500.
1973	The seaward end of Bearskin Neck breakwater was repaired with 5- to 8-ton stone. The stone was placed on two sections, one totaling 55 ft in length on the seaside head and trunk and the other totaling 50 ft in length, the same area repaired in 1970. The repairs consisted of adding stone to void areas such that the resulting side slopes were fairly uniform. Lump sum cost of the repair was \$28,700.

1977- 1978	Repairs were made to the seaward 100 ft of Bearskin Neck breakwater. Existing displaced stone was reset throughout this section and, to complete the repairs, approximately 1,600 tons of new 4- to 8-ton stone were used. The repair geometry had a +18.5 ft mlw crown elevation, a crown width varying from 18 to 28 ft (widest at seaward end), and side slopes varying from 1V:2.5H to 1V:1.5H (steepest at
